USAAMRDL-TR- 75-37

## AXIAL-CENTRIFUGAL COMPRESSOR PROGRAM

General Electric Company  
Aircraft Engine Group  
1000 Western Ave.  
Lynn, Mass. 01910

October 1975

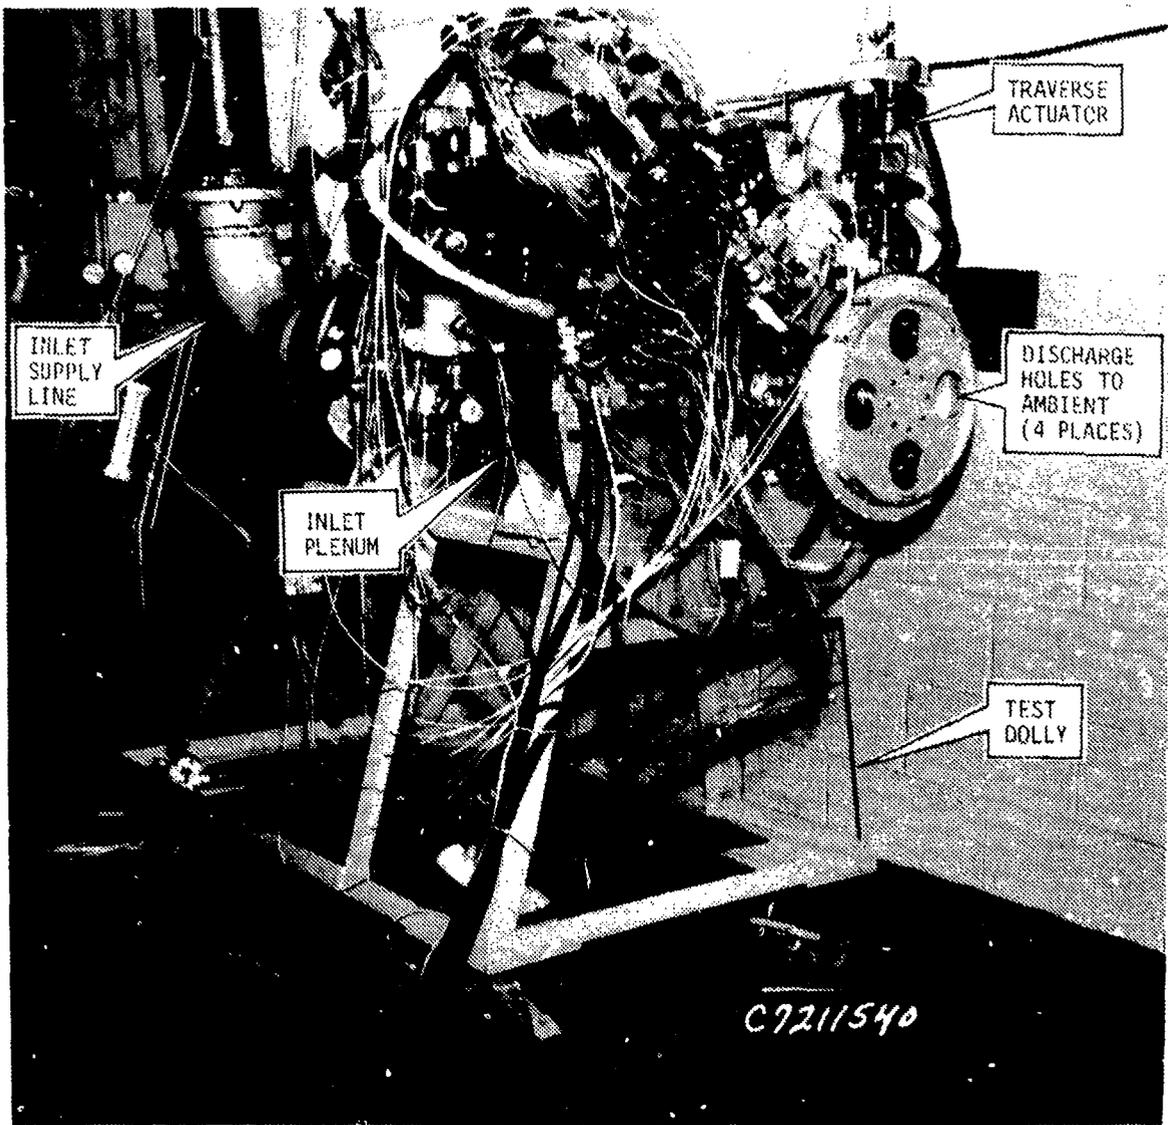
Figure 7. CCV Blow Test Setup.

An adaptor plate was also constructed to centrally mount the dummy rotors from the impeller flange. The assembled hardware is shown in Figure 7.

The inlet airflow was measured by a choked venturi mounted in the inlet supply line, since the test rig discharged to the atmosphere (see Figure 7). Inlet total temperature was determined using eight screen-mounted Chromel-Constantan thermocouples. The inlet total pressure was measured in the inlet plenum with four total pressure baskets.

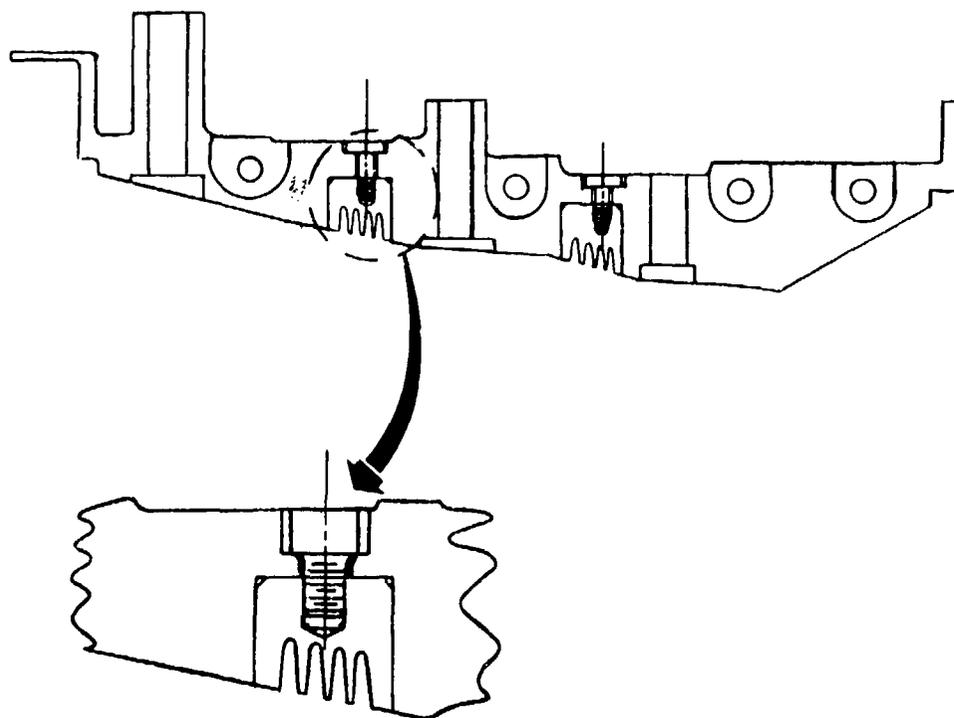
Figure 13. Axial Compressor Casing Inserts.

The compressor casing treatment over the Stage 1 and 2 blades was destroyed in the failure and had to be replaced. Inserts were machined from AM355 forged stock and installed in the compressor casing as shown in Figure 13. The rest of the compressor casing flow path was polished to remove all raised metal, small nicks, and scratches. No significant dimensional changes occurred in the casing.

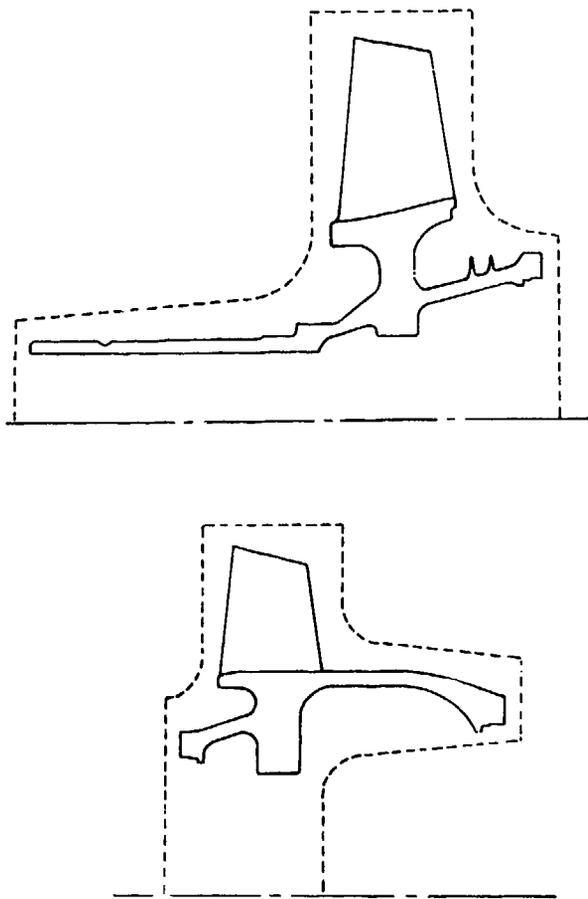
Figure 14. Sketch of Stage 1 and Stage 2 Blisk Contour Forging Outline.

The AM355 Stage 1 and 2 blisks were replaced with parts of the same aerodynamic design machined from 6Al-4V Titanium contour forgings (see Figure 14). A triple vacuum melt titanium alloy was chosen to provide maximum insurance against impurities in the forgings. The structural shape of the blisks was changed as shown in Figure 15 to maintain the rotor frequency margin with the lower modulus of titanium. The same tooling and process used on the original blisks were used for the titanium parts.

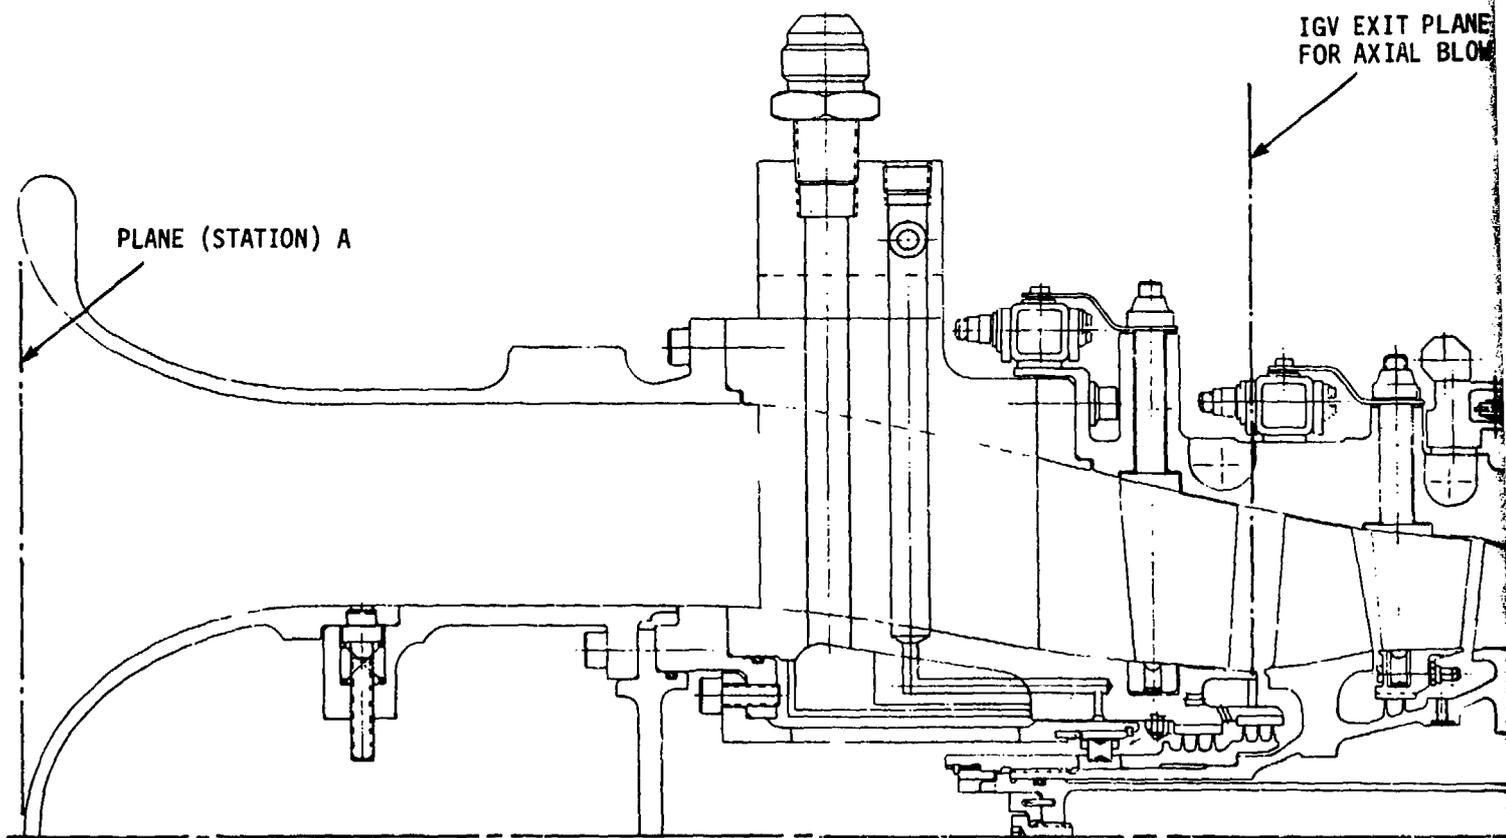
Figure 21. Axial-Centrifugal Compressor Instrumentation Planes.

The Plane B static pressure was determined from six taps located at the following angles (aft-looking-forward): 31°15', 76°15', 121°15', 211°15', and 301°15'. These taps were unequally located to avoid interference with the Plane B bleed air bosses and rake instrumentation pads.

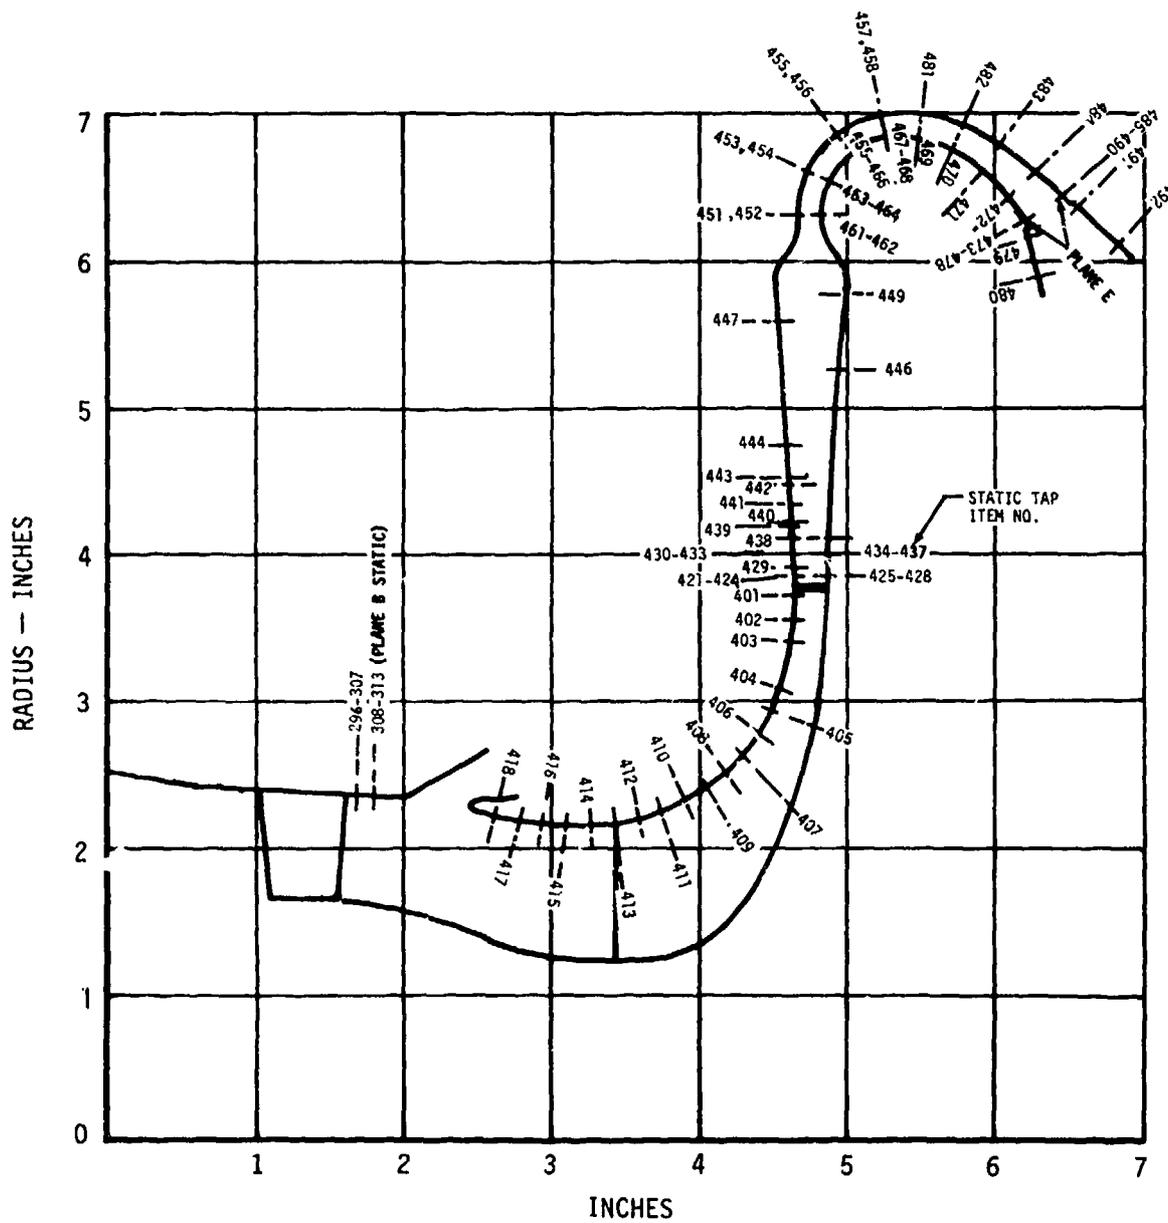
Figure 25. Centrifugal Static Pressures - CCV-I and FCV-I.

Diffuser static pressure taps were provided along a single conical passage with three additional passages instrumented for inlet and throat static pressure for a total of 29 static taps. The flow from the diffuser entered a deswirl vane row. Alternate deswirl vane row passages were instrumented to observe wake flow and core flow passages, since there were twice the number of vanes in the deswirl row as there were passages in the diffuser. The meridional locations of the various diffuser static taps are shown in Figure 25. Twelve static taps were used at the discharge of the exit annular diffuser with six equally spaced taps on the outer wall opposing six taps on the inner wall. The average of these twelve taps was used to determine the compressor outlet static pressure.

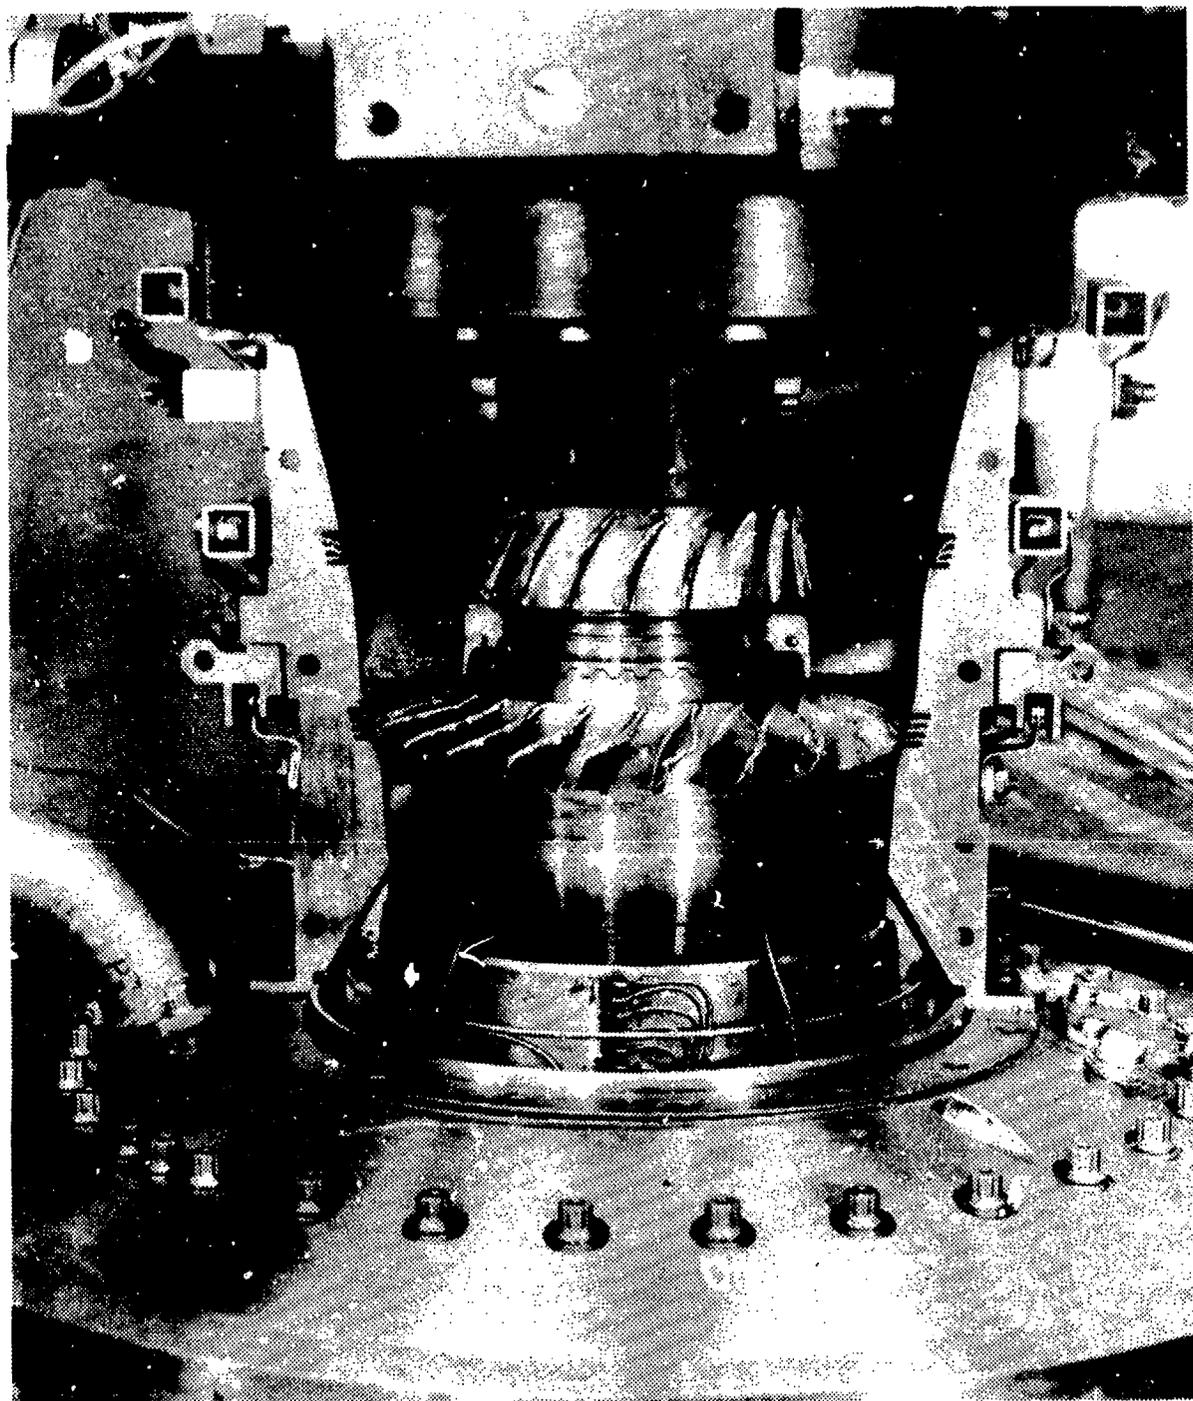
Figure 57. Damaged Rotor and Casing Hardware.

Stage 2 rotor blades showed heavy damage with evidence of fatigue failure at the trailing edge tip corners (see Figure 57).

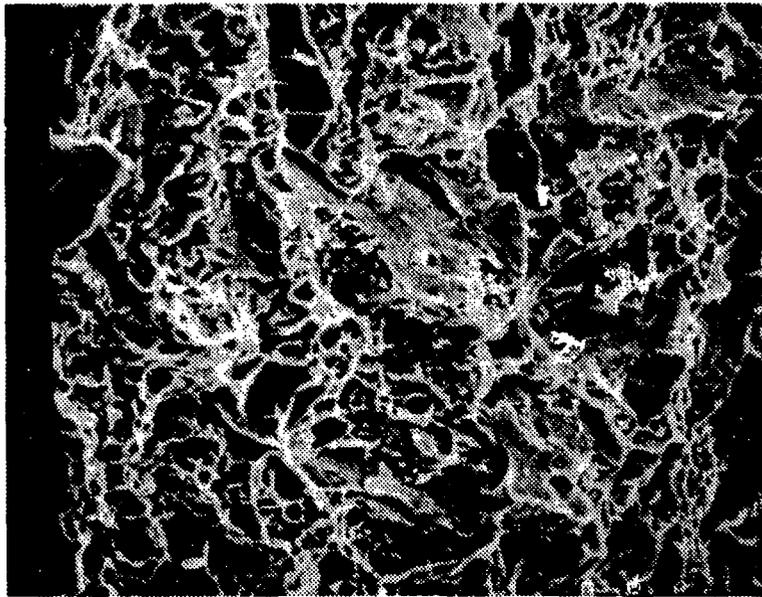
Figure 60. SEM Examination of Stage 1 Blade Stub - 1000 X Magnification.

Remarks: View of typical tensile dimpling and quasi-cleavage in tensile fracture area.

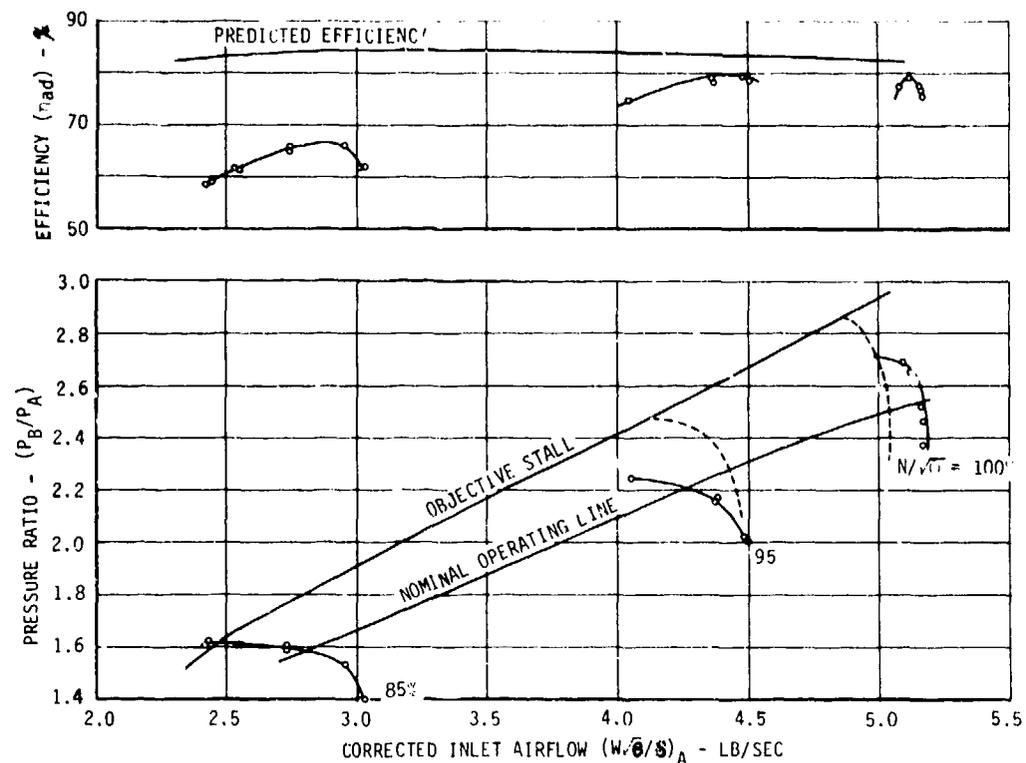
Figure 62. ACV-I Axial Compressor Performance Nominal Stator Schedule.

The performance map of the axial compressor operating with the nominal stator schedule is shown in Figure 62. It may be observed that at 100% corrected speed, the predicted stall pressure ratio was not attained, although the operating line pressure ratio was reached at approximately 3% higher flow. The peak efficiency at 100% speed for the nominal schedule was 78.5%, which is approximately 4-1/2 points lower than the objective. At lower corrected speeds, the efficiency gap increases, as may be seen from the map in Figure 62.

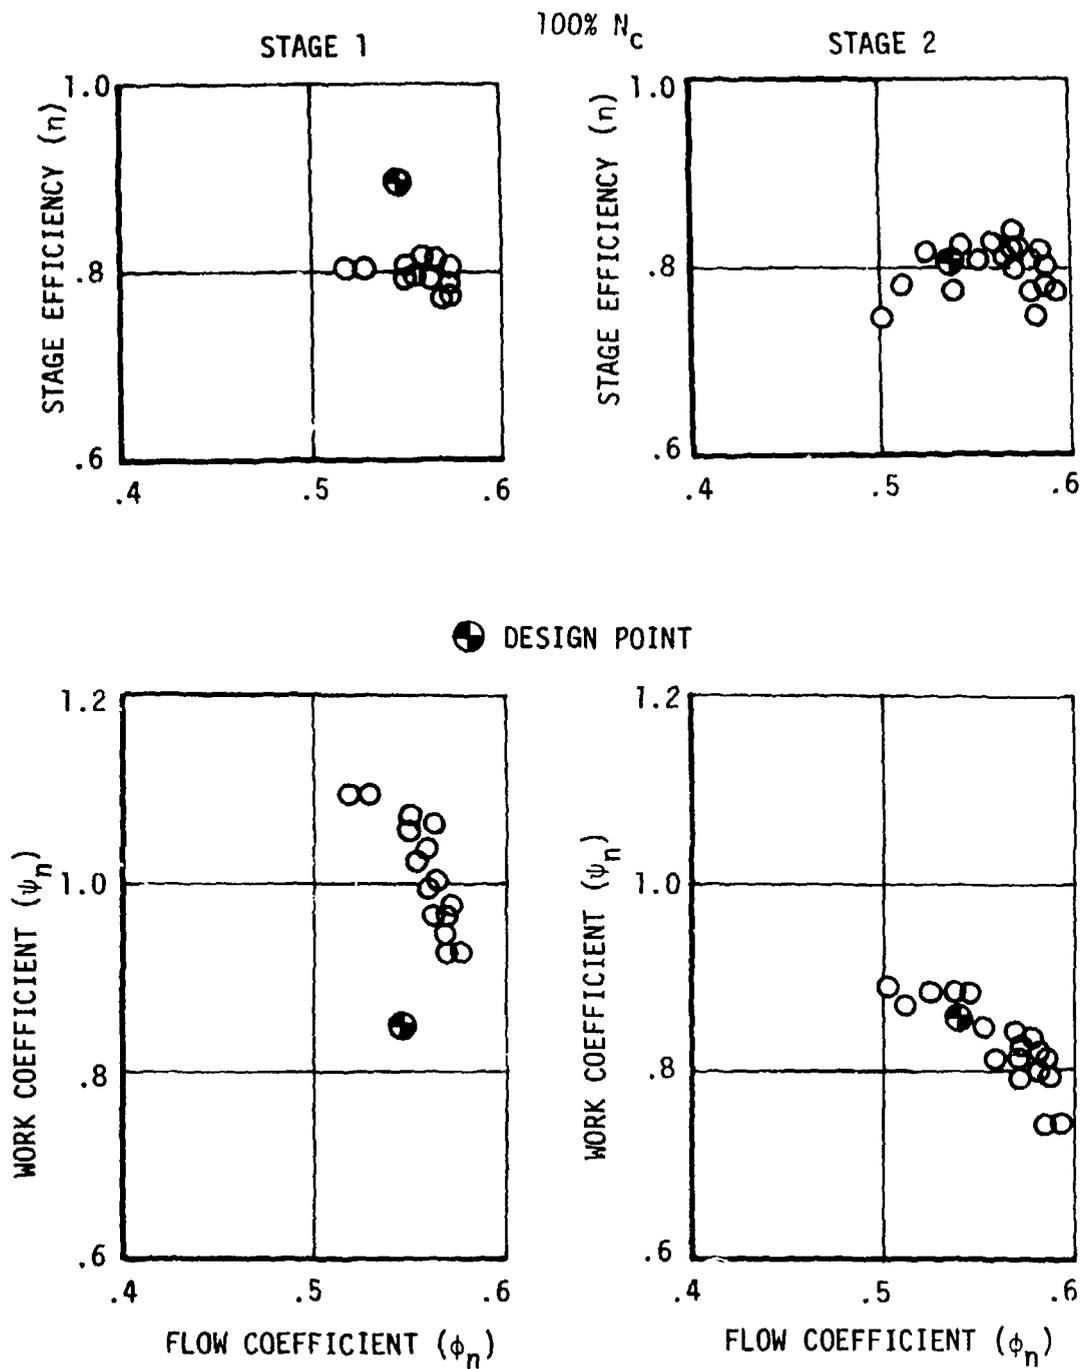
Figure 72. Axial Compressor Normalized Stage Characteristics - 100% Corrected Speed.

These results at 100% corrected speed indicate that the work input of the first stage was higher than design and the efficiency was about four points low (see Figure 72). The second stage results indicate that the work input was a little below the design intent, but the efficiency was at the design objective level. These results identify a deficiency in the first axial stage which was also apparent in the effectivity results. The fact that the second stage work input is somewhat low may be due to the flow profile from the first stage. The test results at 95% and 85% corrected speed show a similar trend (see Figures 73 and 74). The wider scatter of test data at 85% corrected speed is a result of the large variation in stator settings which were tested. The range of vane angles at 95% and 100% corrected speed was less than at 85% corrected

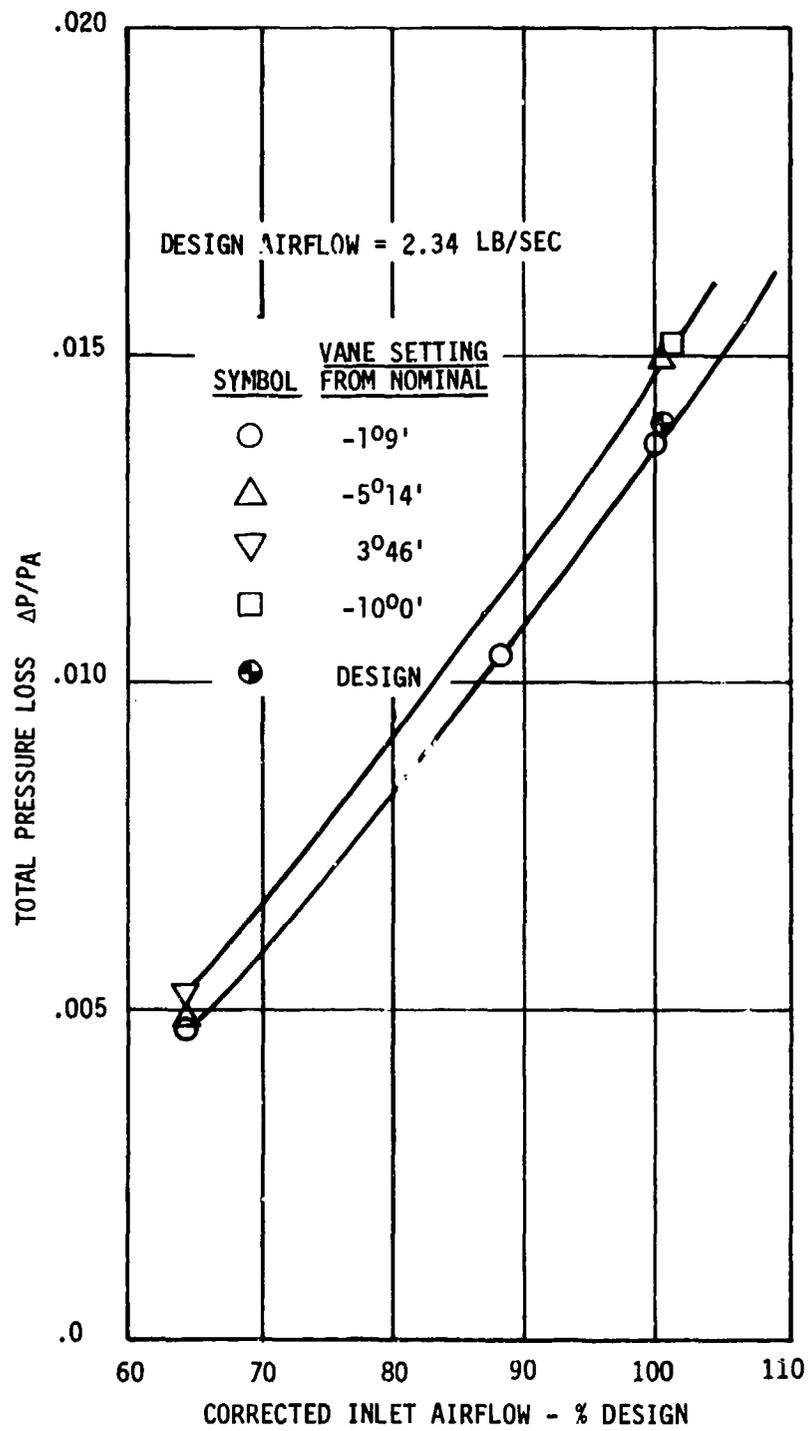
Figure 87. Total Pressure Recovery Factor vs Corrected Inlet Flow.

The results of weight-averaging the profiles to determine a total pressure recovery coefficient for the configuration are shown in Figure 87. It is apparent that the nominal stagger condition represents

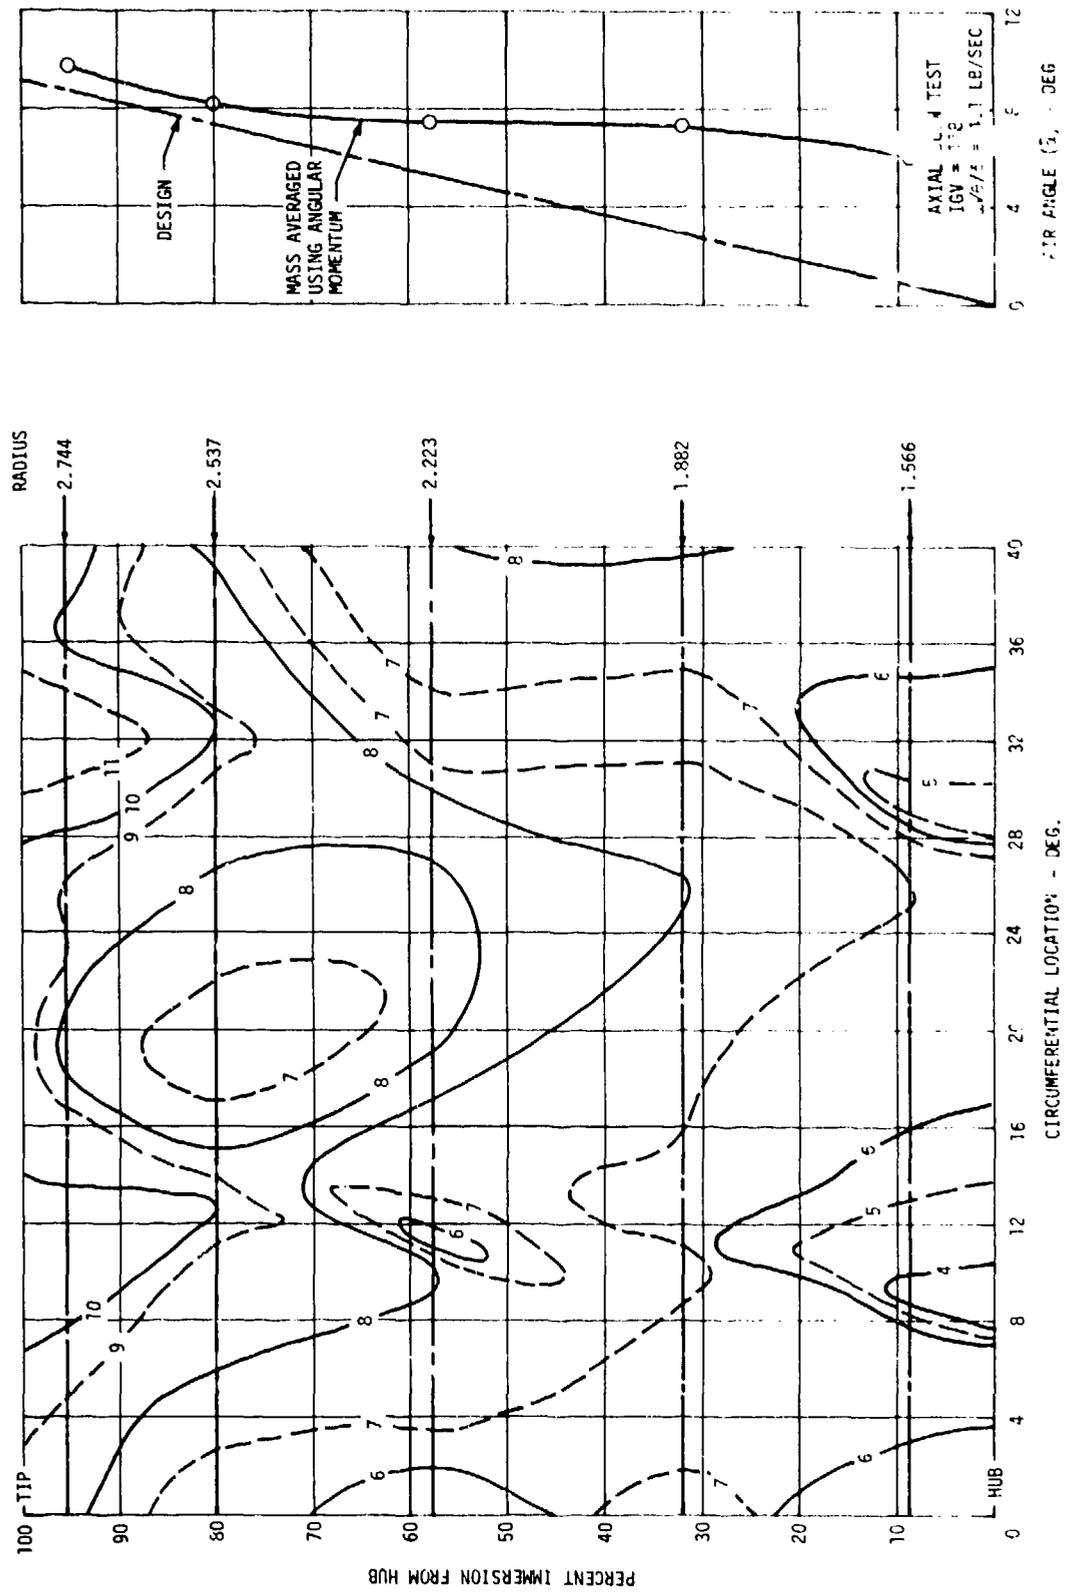
Figure 101. Axial Blow Test - Outlet Angle Contours.

Contours of outlet flow angle were plotted in Figures 101 and 102 for the test results at  $-1^\circ 8'$  and  $10^\circ$ , respectively. The contour plot of vane total pressure drop is shown in Figure 102 for the  $-1^\circ 8'$  data set. The vane wakes were readily observed on these contour charts. The warp in the trough of high pressure drop shown in Figure 103 approximated the twist of the trailing edge of the inlet guide vane.

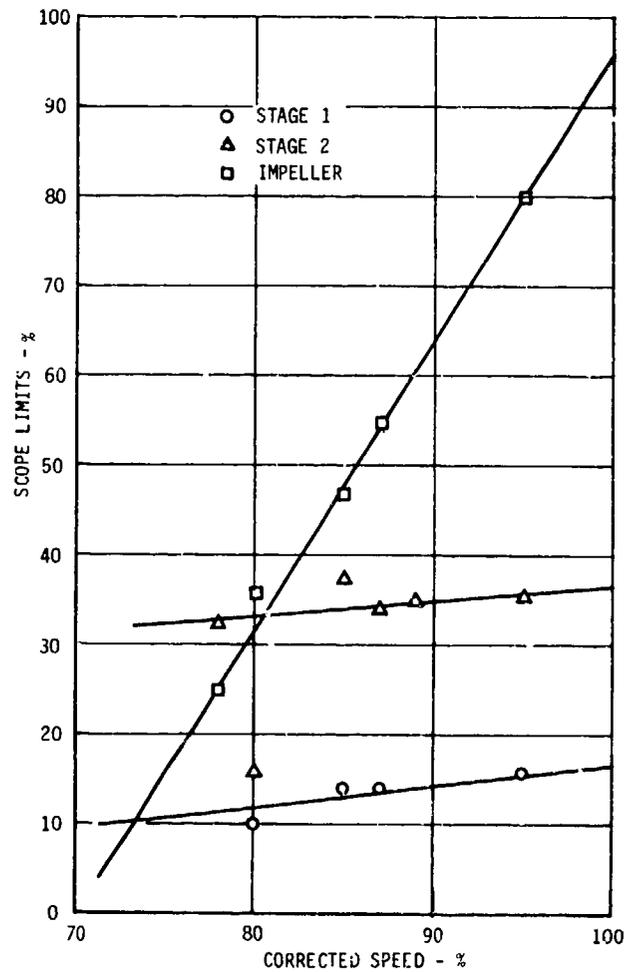
Figure 128. FCV-I Rotor Blade Stall Stresses.

The FCV-I was stalled at various speeds from 78% to 95%  $N/\sqrt{\theta}$  with a maximum response of 70% limits, which for stall stress is well below acceptable levels (see Figure 128).
